21st European Conference on Fracture, ECF21, 20-24 June 2016, Catania, Italy

Crack surface morphology and grain misorientation in fatigued aluminium alloy AA7050 samples after interrupted ageing and retrogression-reageing treatments

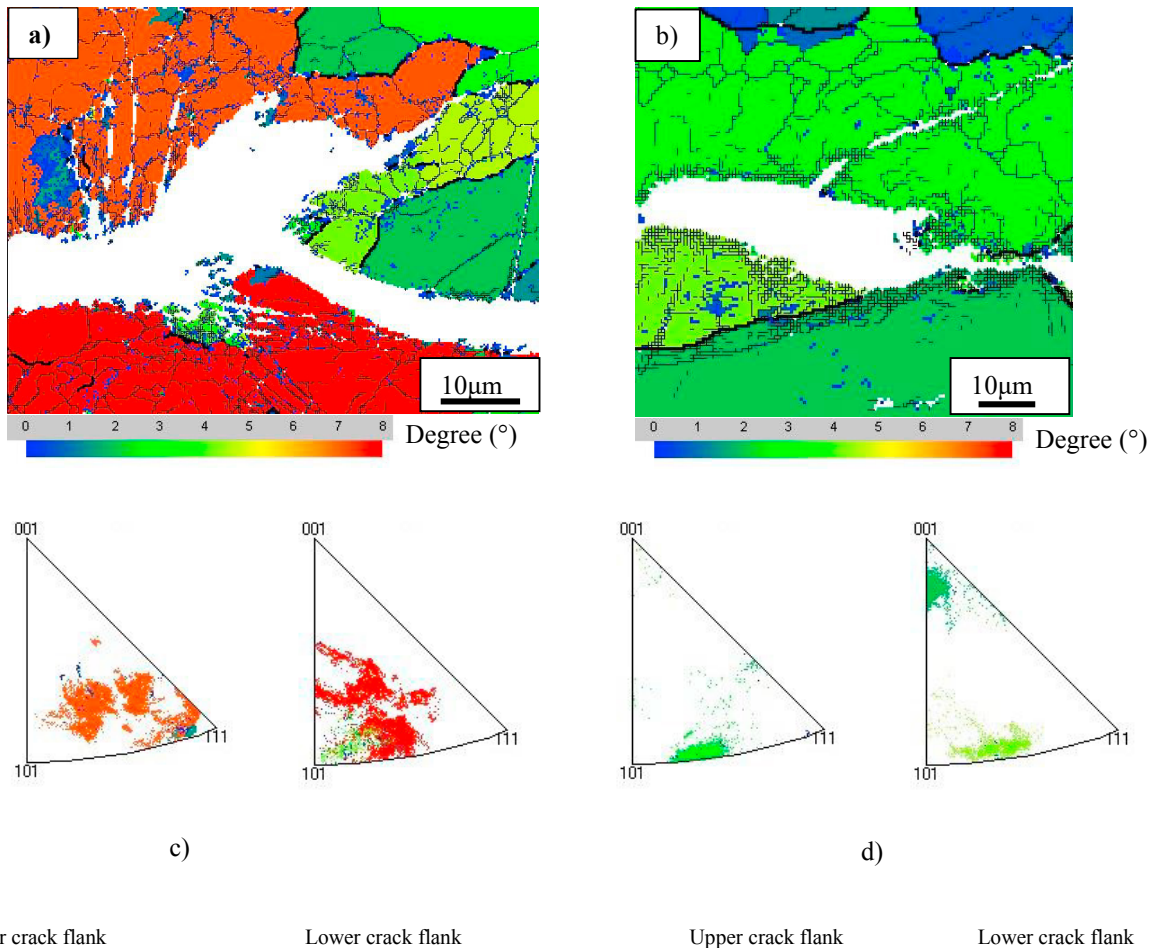
Fig. 3. Plastic deformation zone regions as consequence of applied overload is shown at the crack flank corresponding the encircled (1 and 2 of Figs. 2a-b) regions. (a) and (b) mean misorientation maps from the T614-65 and RRA conditions; respectively. (c) IPF triangle projections for the upper and lower sides of the crack wake from the T614-65 condition; (d) IPF triangle projections for the upper and lower sides of the crack wake from the RRA condition.

The average misorientation maps can be seen in Figs. 3a-b, which display the difference of misoriented area (indicated by difference in colors in the maps) at the overload regions and the crack wake. It is concluded that these different misoriented areas correspond to the plastic deformation zone associated with applied overload at the crack

wake for both conditions. Thus, the misoriented area with 8° (red color in Fig 3a) indicates higher density of subgrain structure (low-angle boundary) than the misoriented area with 4° (light green color in Fig. 3b) for both T6I4-65 and RRA conditions. In this case, it is revealed that a gradient of misorientation corresponds to the minimum to maximum misorientation angle between $0 - 8^\circ$. Hughes-Hansen (1997) reported that the tendency of grain towards subdivision is distinctly orientation-dependent. The deformation behavior of each grain depends clearly on its initial orientation. It is known that for some orientations deformation takes place in a stable manner producing low misorientation, according to Sandim et al. (2001). These observations can explain the regions with low misorientation (blue color on the scale) even in the plastic deformation zone due to the applied overload, as shown in Figs. 3c-d.

Moreover, the orientation with respect to the laboratory coordinate system was determined and is presented using IPF triangle projections for the upper and lower shores of the crack in the overload region for both T6I4-65 and RRA conditions, as can be seen in Figs3 c-d. For the T6I4-65 condition (Fig. 3c) it is noted that the orientation is equally spread for both sides of the crack wake. In contrast, for the RRA condition a clear difference is observed between the lower and upper flanks of the crack wake, as can be seen in Fig. 3d.

It was recently reported by Chen et al. (2013) that multistage ageing treatment produce bimodal microstructures containing both shearable and shear resistant precipitates that contribute to the increase in the occurrence of planar slips. In the AA7050 aluminium alloy these planar slips display wavy slip features, as described by De et al. (2011). However, it is surmised that these features of the planar slips shown in Figs 1a-b can contribute to the formation of substructure with different misoriented areas illustrated in Figs 3a-b.
