DOI:10.1016/j.catena.2024.108439

Catena

Assessing the effect of torrent control structures on sediment continuity and connectivity

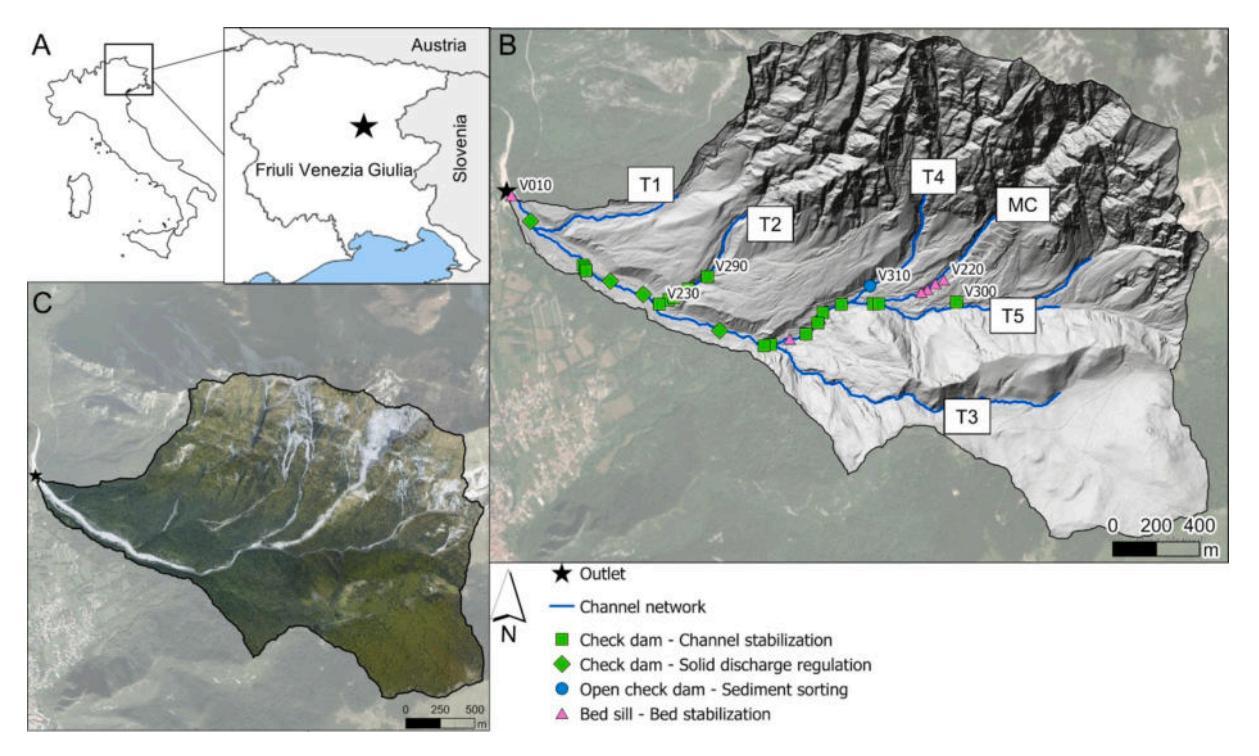
Fig. 1. Location of the study catchment (A) in the Friuli Venezia Giulia Region (Italy). The Vegliato (B) is characterized by several torrent control structures, located along the main channel (MC) and tributaries (T1-5), classified according to different functions. The active channel and sediment sources are visible even though the forest covers most of the catchment (C).

The study area is the Vegliato catchment, located within the municipality of Gemona del Friuli (UD), NE Italy, in the Julian Prealps (Fig. 1A). The catchment spans an area of 4.4 km² considering the outlet as visible in Fig. 1B, and it features elevation ranging from 355 to 1739 m a.s.l, with an average slope of 35°. The channel network extends approximately 9 km, draining from Mount Chiampon (1709 m a.s.l.), Mount Deneal (1701 m a.s.l.) and Mount Cuarnan (1372 m a.s.l.), before converging into the Ledra River, a tributary of the Tagliamento River. A large alluvial fan develops at the base of the reliefs, where the municipality of Gemona del Friuli is situated. The valley's central line aligns with a significant east-west oriented fault known as the Periadriatic (Barcis-Staro Selo in Carulli, 2006 and Gemona-Kobarid in Zanferrari et al., 2013). The lower part of the catchment is mainly covered by a typical mesophytic mixed deciduous forest comprising manna ash (Fraxinus ornus), hop hornbeam (Ostrya carpinifolia) and beech (Fagus sylvatica). In contrast, vast areas in the upper part and channel banks have been reforested with coniferous species, primarily black pine (Pinus nigra) and spruce (Picea abies). Notably, a consistent portion of the study area is covered by bare rock and loose sediments, while grasslands and open meadows constitute only a minor portion of the overall land cover (Fig. 1C).

In response to the geomorphic challenges in the area, a diverse torrent control system was built up, consisting mainly of check dams, bed sills and bank protection structures (Fig. 1B). Focusing on the transverse structures, currently the Vegliato Torrent has 24 check dams and 7 bed sills (Martini et al., 2023). These structures are located along the main channel and in some of the tributaries and were identified by a unique code with the initial letter of the basin and a progressive number (e.g., V010). Thus, in this study, the channel network has been divided into six distinct reaches: the main channel and five tributaries. The main

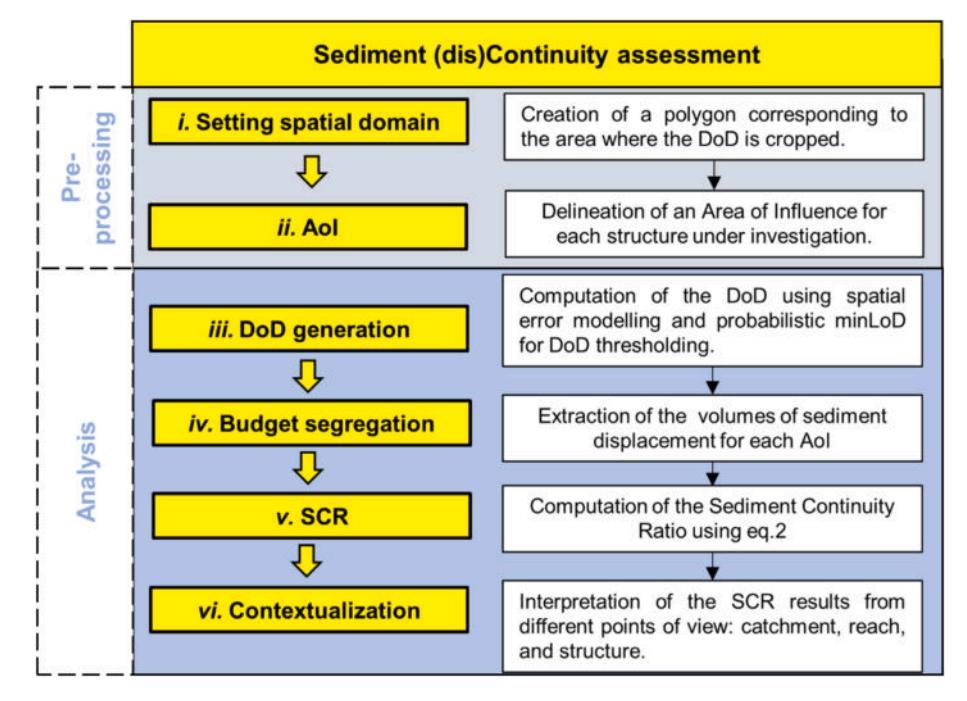
Fig. 2. Workflow of the (dis)continuity assessment carried out in this study. Progressive steps were followed and grouped according to two main sections concerning data pre-processing and analysis.

Within the study catchment, a spatial domain was delineated (Step i, Fig. 2), representing the area in which a DoD analysis was performed. The domain was shaped starting from the active channel and applying a variable buffer along the channel network (1 to 50 m) to ensure that all morphological variations and torrent control works were included. In the Vegliato Torrent, the domain included the five tributaries (T1, T2, T3, T4, T5) and the main channel. Within the spatial domain, an Area of Influence (AoI) was delineated for each structure (Step *ii*, Fig. 2), using the exact position obtained from the database (Martini et al., 2023). For the computation of the SCR in the Vegliato catchment, where multiple torrent control works are built along the channel network, an AoI was defined as the channel reach that extends from a structure to its closest upstream one. In other contexts, different approaches might be considered, such as those based on slope breaks in the longitudinal profile, main sediment transport process (e.g., debris flows, debris flood, bedload), or multi-criteria methodologies (e.g., Rinaldi et al. 2013).

To obtain volumetric data on sediment mobilization between 2019 and 2022, the 2022–2019 DoD of the Vegliato catchment (**Step iii**, Fig. 2) was used. The DoD was generated starting from two DTMs with a spatial resolution of 1 m, which were derived from the interpolation of co-registered point clouds (point density between 16 to 21.6pt/m²) acquired by ALS surveys conducted in 2019 and 2022. The error propagation procedure, based on the Fuzzy Inference System (FIS) approach, and the probabilistic minLoD thresholding were adopted to ensure robustness of the final DoD (more information in Cucchiaro et al., 2024).

The DoD budget segregation function, available in the Geomorphic Change Detection toolkit (GCD; Wheaton et al., 2010), was used to extract the volumes of sediment displacement (m^3 of sediment erosion and disposition) in each AoI (Step *iv*, Fig. 2).

The SCR for each i^{th} structure was computed (**Step v**, Fig. 2) after few mathematical steps (Supplementary material, table S.1) using the final formula (eq.2)

- ii) Reach: the SCR was analyzed in respect to the area, length and slope of the AoIs to observe potential patterns related to the characteristics of the reaches, since the sediment eroded or deposited within an AoI can be intrinsically limited or promoted by its length, area and slope. Therefore, to compare the results of SCR among different structures, these three variables were extrapolated from the AoIs (**Step** *ii*, Fig. 2).

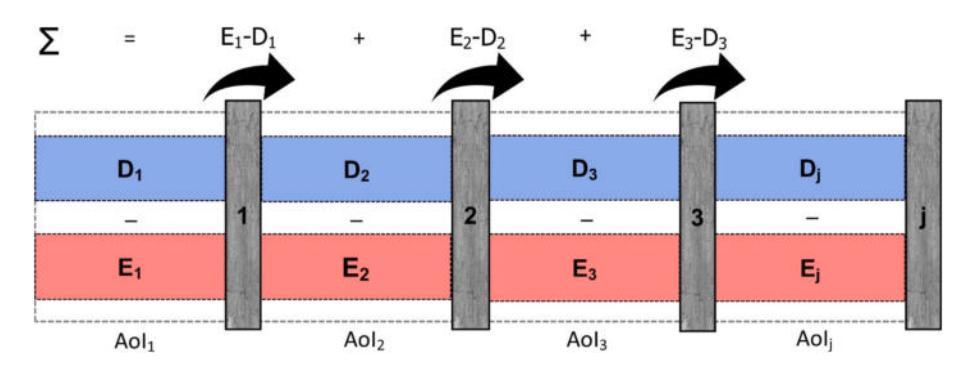
Fig. 3. Schematic representation of the SCR. For each AoI, the volume of sediment eroded (E), deposited (D) and the difference between the two, is involved. The cumulative net fraction of sediment passed over the upstream structures is also considered.

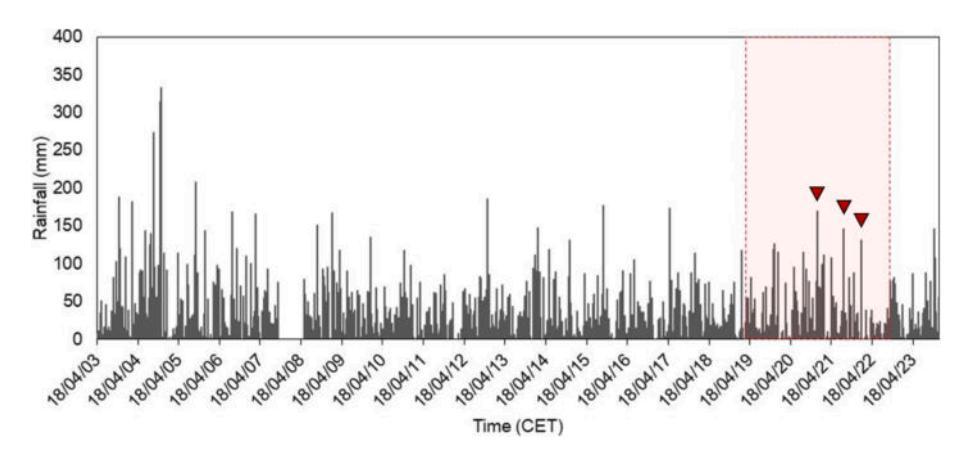
Fig. 4. Daily rainfall recorded by the Gemona del Friuli (307 m a.s.l.) meteorological station from April 2003 to October 2023. The red area refers to the 3-year study period, in which the three main rainfall events are identified.

The chart of daily precipitations is shown in Fig. 4, where 20 years of data are presented. The largest event ever recorded was in 2004, when more than 320 mm were measured on November 10th. Focusing on the time window under investigation (2019–2022), it is possible to notice the highest peak corresponded to 168.6 mm (08/12/2020–09/12/2020). Furthermore, other two events showed remarkable daily precipitations, with cumulated values over 130 mm (30/07/2021 and 05/01/2022–06/01/2022).

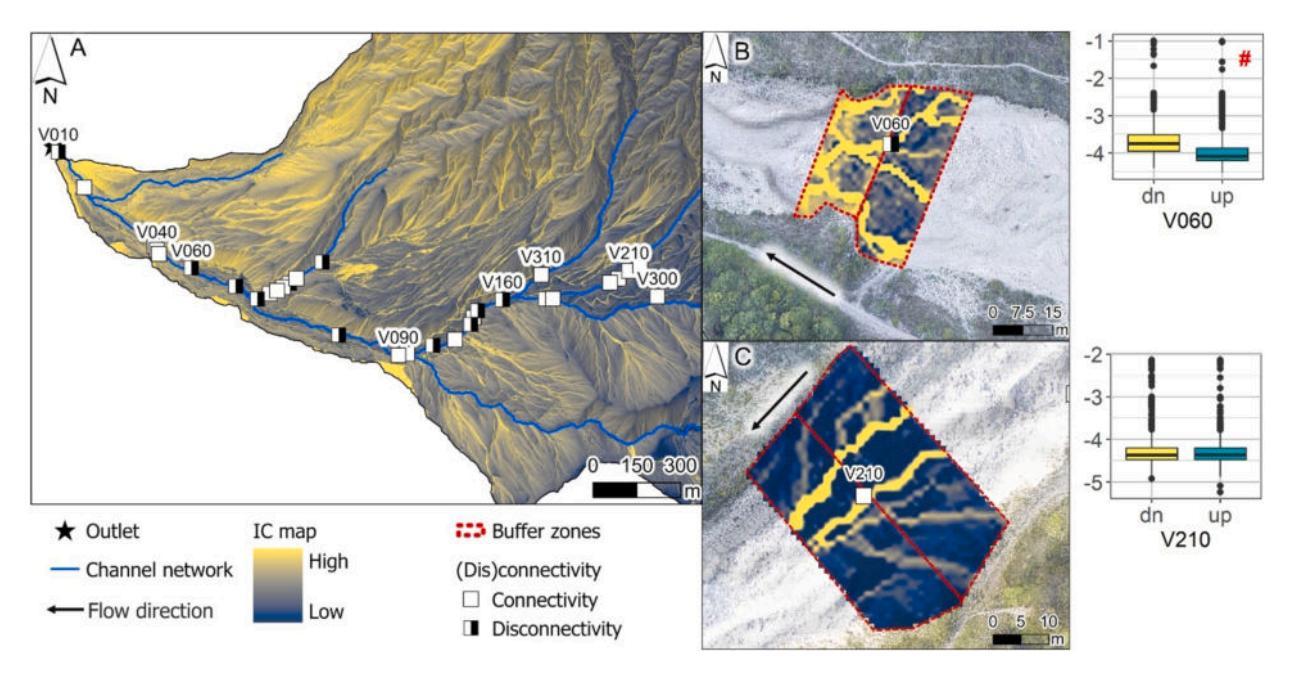
Fig. 5. Map of the torrent control works showing connectivity or disconnectivity (A). Downstream (dn) and upstream (up) IC values were extrapolated from the catchment-scale IC map within buffer zones located in proximity of each structure. Difference between upstream and downstream distributions of IC values was tested (p < 0.01) for statistical significance (#). The figure includes an example of a structure with statistically different IC values, hence showing disconnectivity (B), and a structure with statistically similar IC values, hence showing connectivity (C).

The effect of torrent control structures on (dis)connectivity was determined by the Mann-Whitney test, depicting significant difference (p-value < 0.01) between downstream and upstream IC values (full results in the supplementary material, Fig. S.1). There is a slight imbalance between the number of structures showing disconnectivity (39 %) and connectivity (61 %; Fig. 5A). Considering the spatial distribution, in the lower and flatter part of the main channel (V010-V090), the series of check dams including V040 is characterized by connectivity. In the middle part of the main channel (V090-V160) and along T2, the structures are alternating between disconnectivity and connectivity, whereas in the upper part of the catchment most of the structures (e.g., V210, V310) show connectivity.

Whether a structure shows connectivity or disconnectivity depends on the difference between upstream and downstream geomorphic conditions, which in turn influences the IC values. In the Vegliato catchment, torrent control works exhibiting significant differences in IC, indicating disconnectivity, also show lower IC values upstream than downstream. Fig. **5B** shows the example of check dam V060. In the upstream zone, the presence of thick alluvial sediment deposits reduces the IC by decreasing the slope and concentrating the flow toward the spillway. In contrast, in the downstream zone, the slope increased due to a significant step in the profile caused by deep erosion processes, which in turn increased the IC. On the other hand, structures showing connectivity have no statistically different IC distributions. In the example of V210 (Fig. 5C), no substantial geomorphic differentiation was provided by channel bed topography to alter the two main visible sediment pathways considerably, making the difference in the distribution of IC values not significant.

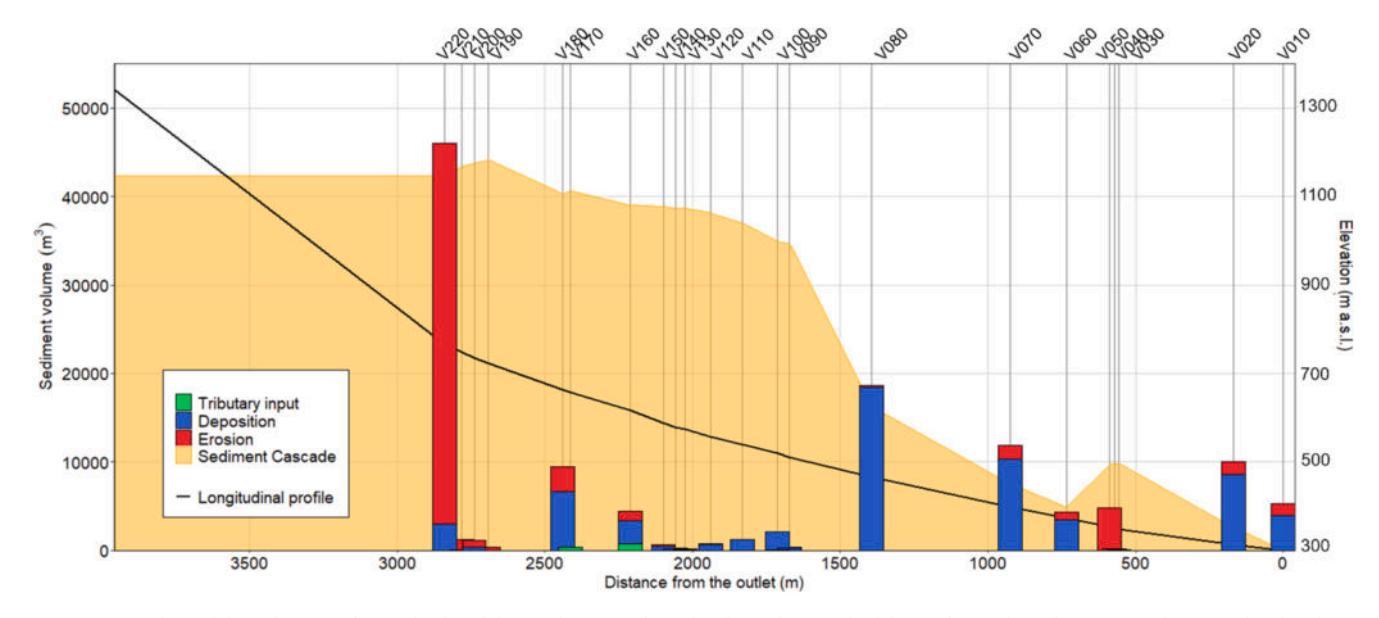
Fig. 6. Summary chart of the sediment volumes displaced during the event along the channel network of the Vegliato. The sediment cascade is visualized with regard to the main channel, with erosion and deposition volumes isolated for each Area of Influence (AoI) and presented at each structure. The net sediment fraction from the tributaries is also presented as it provides an additional input to a specific AoI along the main channel and to the overall sediment cascade.

Most of the volume mobilized during the 2021 event, was eroded from the headwaters (42290 m³), upstream structure V220 (Fig. 6), where the steep channel (slope of 54 %) facilitates the downstream sediment transfer. In Fig. 6, the distribution of the volumes of erosion, deposition, and overall sediment cascade is represented throughout the main channel. From the upstream part, the sediment cascade was partially discontinued in correspondence of two close structures, V180 and V170, where the slope decreases to 25 % and 16 %, respectively. A large deposition corresponding to 6642 m³ is visible, although associated with 2818 m³ of erosion. However, the largest depositions are registered at V080 and V070 AoIs, where 18486 m³ and 10306 m³ were recorded, respectively. At this point, the sediment cascade was greatly reduced. Moving downstream, it increased again at V050, where 4853 m³ were eroded, and finally, it balanced out at V020 and V010, where the slope reach the minimum of 8 %. The input of the tributaries, highlighted in green as part of the sediment cascade, was maximum 714 m³. All volumes can be found in table S.2 (Supplementary material).

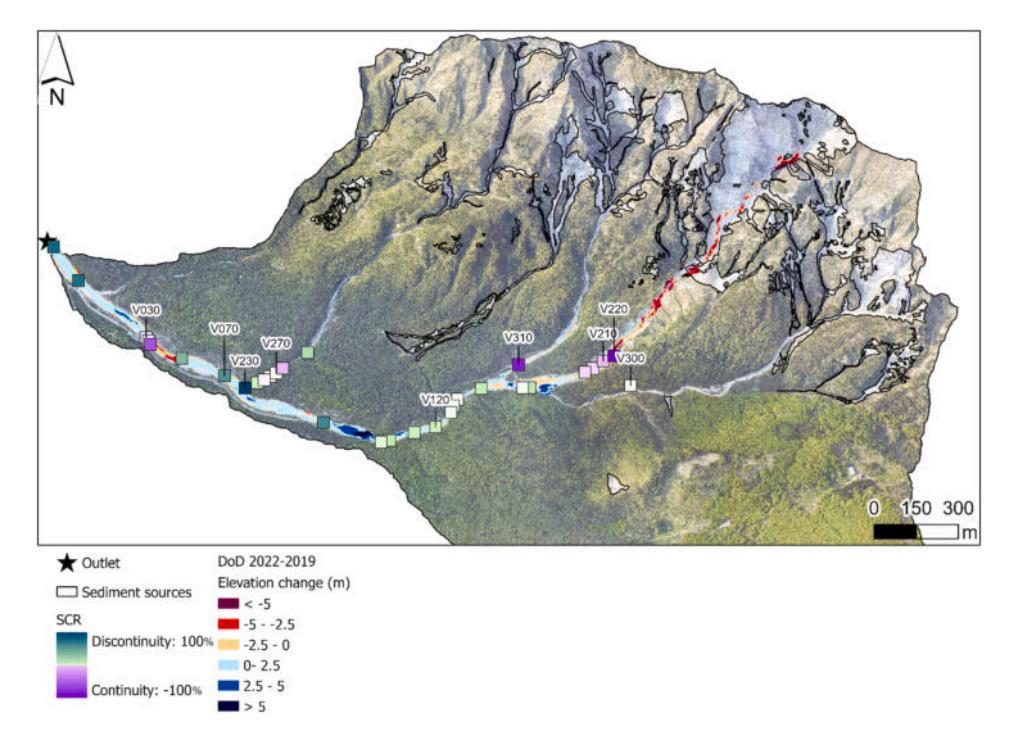
Fig. 7. Map of the torrent control structures and corresponding SCR. The geomorphic changes are also visible thanks to the 2022–2019 DoD, with negative values indicating erosion and positive values deposition. Sediment source areas represent active areas potentially supplying sediment. No significant newly formed areas were detected between 2019 and 2022.

The spatial distribution of SCR is indicative of how structures influenced the continuity or discontinuity of the overall sediment cascade (Fig. 7). For instance, continuity is more evident in the upper catchment, near the four bed sills built in series (V190, V200, V210, V220), and close to the major channel erosion and the largest sediment source (13.5 ha), which accounts for the 3 % of the entire area of the basin. Therefore, due to their position, these structures were inevitably more prone to erosion processes rather than deposition. Other examples of torrent control works that showed high continuity were V310 (SCR of -71.4 %) and V050 (SCR of -49.9 %). The former is located in the downstream section of T4 and potentially receives sediment supply from two large branching sediment sources contributing to the tributary; the latter is located in the downstream main channel, affected by local channel erosions and far from being affected by sediment supply from the hillslopes. On the contrary, it is possible to observe multiple structures that favoured discontinuity in the middle and downstream reaches of the main Vegliato channel, where deposition processes became predominant (Fig. 6 and Fig. 7) and the sediment sources can contribute through T1 and T2.

Finally, the two extreme values of SCR were represented by V220 (-88.4 %), and V230 (100.0 %) along T2, whereas V270 and V300 exhibited a SCR of 0 due to the absence of sediment mobilization.

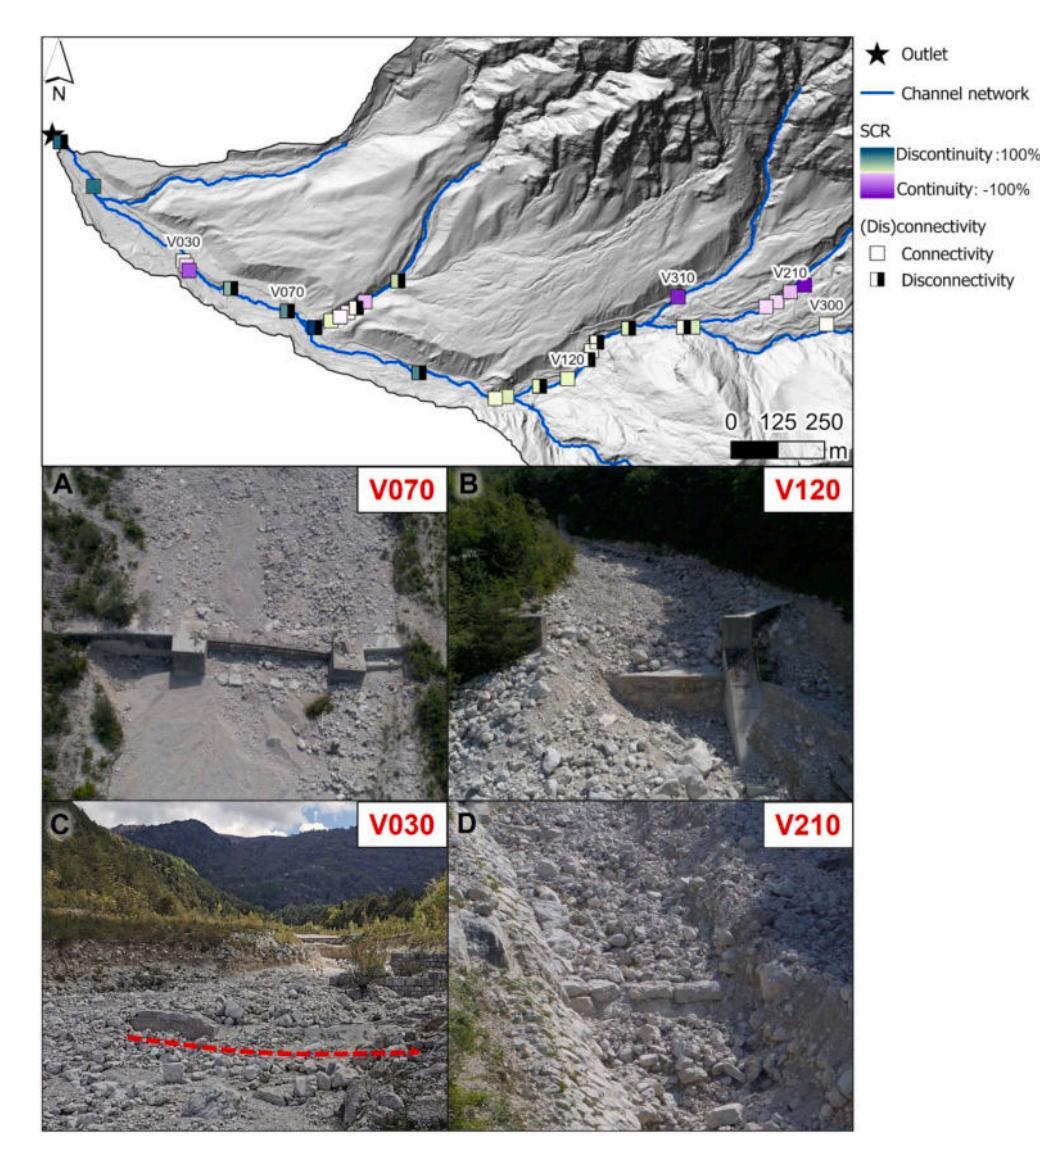
Fig. 8. Map of the torrent control works classified according to the effect on (dis)continuity (negative or positive SCR) and sediment (dis)connectivity (difference in IC). Examples of: check dam (V070) prone to both connectivity and continuity (A); check dam (V120) limiting continuity but not connectivity (B); collapsed check dam (V030), highlighted in red, again limiting continuity but not connectivity (C); bed sill (V210) prone to both continuity and connectivity (D).

The SCR and IC results are combined in Fig. 8 to provide a joint assessment. The 36 % of the torrent control works show both sediment discontinuity and disconnectivity, being characterized by a positive SCR and a significant difference of IC upstream against downstream. A peculiar example is V070, a traditional check dam with a solid discharge regulation function. In Fig. 8A, the check dam V070 presents upstream deposition rather than erosion and it also shows longitudinal disconnectivity. The 29 % of the torrent control works has intermediate behaviour, namely they favoured discontinuity (i.e., positive SCR) but

they do not show significant variations of IC from upstream to downstream. For instance, check dam V120 (Fig. 8B) shows an uninterrupted sediment deposit wedge on the spillway and evidence of outflanking. This indicates a propensity for deposition and discontinuity, as well as an inability to confine the sediment pathways in the spillway and to create a slope break in the longitudinal profile, thus not creating disconnectivity. Another example is check dam V030, which is mostly collapsed but still exerts some residual effect on continuity by acting as a groyne, protecting the left bank and favouring deposition (i.e., positive, although low, SCR), while not affecting significantly the IC pathways, hence showing connectivity (Fig. 8C). On the contrary, no structures show both continuity and disconnectivity. Finally, 29 % is the proportion of structures that show both continuity and connectivity (i.e., negative SCR and no significant difference in IC). Among this group, bed sill V210 (Fig. 8D). The remaining 6 % regard those elements that scored an SCR of 0, hence no effect on the sediment cascade.

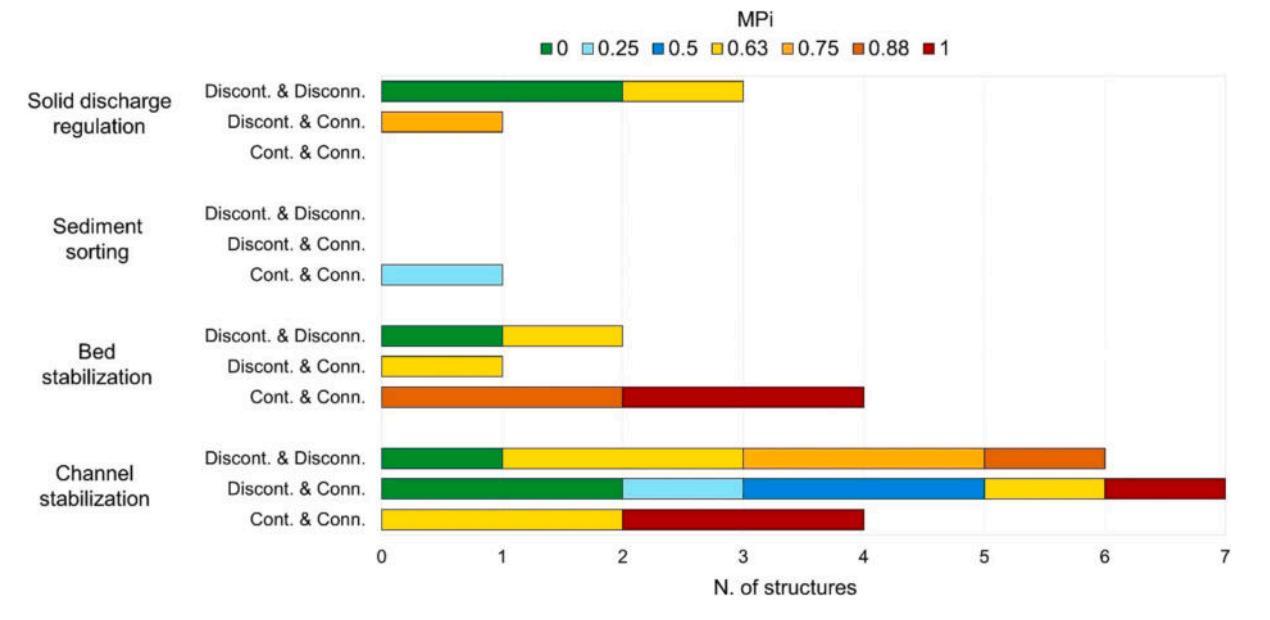
Fig. 9. Stacked bar chart of the torrent control works grouped according to their classified function and to their effect on (dis)continuity (Discont. or Cont.) and (dis) connectivity (Disconn. or Conn.). The Maintenance Priority index (MPi) is also visualized for each structure.

Fig. 9 presents how three groups of torrent control works, specifically discontinuity-disconnectivity, discontinuity-connectivity, and continuity-connectivity, are sorted by function and maintenance condition. For solid discharge regulation function, most of the structures are characterized by discontinuity and disconnectivity (3 out of 4), aligning

with the goal of buffering upstream deposits and preventing sediment continuity during extreme events. The MPi values indicate that no severe maintenance is required for these structures. The only structure expected to sort sediment particles (open check dam V310) is built to permit the longitudinal continuum of sediments fluxes while selectively retaining only the largest boulders. The results are consistent to this mechanism, since the check dam is prone to both continuity and connectivity and the MPi (0.25) points out a partial clogging (between 33 %and 66 %) caused by the largest grains. Bed sills, intended to stabilize the bed and prevent localized erosion, should limit continuity as intended in this work. However, more than 50 % (4 out of 7) of the bed stabilization sills were prone to continuity and connectivity and in fact the MPi values (0.88-1) indicate severe lacks functionality and poor physical status. Finally, channel stabilization structures are supposed to prevent sediment production by reducing channel wandering and bed incision, hence they should theoretically favour discontinuity and disconnectivity. Four structures did not favour discontinuity and disconnectivity and these are mainly characterized by poor maintenance conditions (MPi equal to 0.63 and 1). Worth mentioning are the structures characterized by good status but low functionality (i.e., MPi between 0.25 and 0.5), which all showed intermediate discontinuity and
